Evaluation of MEMS-based In-place Inclinometers in Cold Regions

Margaret M. Darrow, Ph.D.
David. D. Jensen, E.I.T.

December 2012

INE/AUTC 12.38

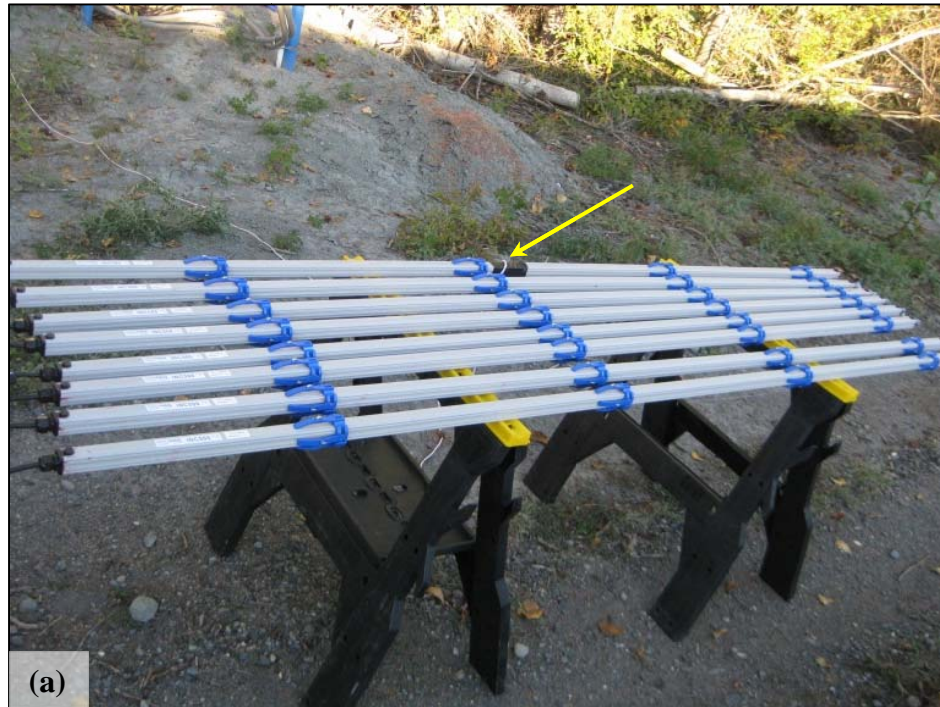
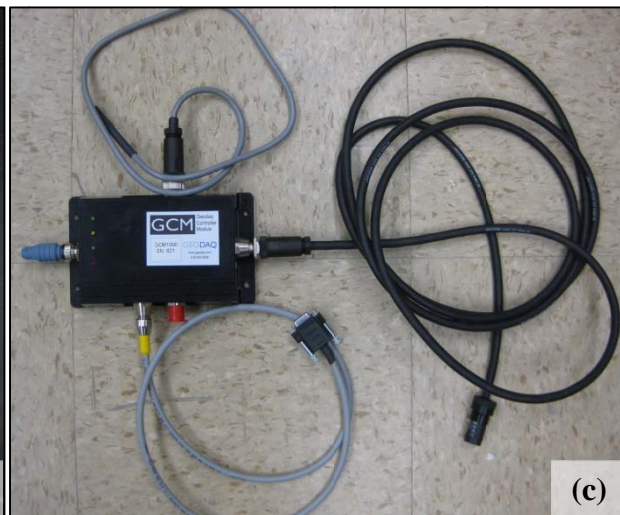
Figure 1. Components of the Geodaq INC500 device. (a) Modules prepared for installation; the yellow arrow indicates a safety line attached to the lowest module. The other components necessary to complete an installation are (b) coupler assemblies, centralizers, a slotted fork to hold the INC500 within the casing, and (c) the GCM controller module. (Photographs by M. Darrow)

The INC500 device consists of 8-ft long flexible modules that contain a series of MEMS-based accelerometer sensors, which measure tilt (see Figure 1). In a standard module, these biaxial sensors are located every 12 in., along with a temperature sensor that has a reported accuracy of $\pm 3^{\circ}\text{F}$ (GEODAQ, 2010) and is not calibrated unless specified by the customer. The modules are

joined by underwater electrical connectors, and the connections are stiffened by a coupler assembly, in order to give the entire instrument length a uniform rigidity. Additionally, three to four centralizers are mounted along the length of each module. Each centralizer contains four stainless steel wheels that are designed to guide and orient the device within a guide casing. Because of its modularity, an INC500 device can be lengthen or shortened to accommodate the geometry of a given installation. The order of the modules as installed within the casing must be recorded, as this order is an input parameter into a setup file for the software program to calculate displacement (see Figure A-6). The INC500 must be installed so as to rest on the bottom of the casing. Because of the potential difference in length between the joined modules and the total casing depth, the INC500 may rest slightly lower or higher than the ground surface within the casing (J. Lemke, pers. comm., March 2010). The INC500 instrument acquired for this research contained bi-axial sensors oriented only for a vertical installation. The manufacturer can make a model for both vertical and horizontal applications, which requires additional sensors (J. Lemke, pers. comm., March 2011).

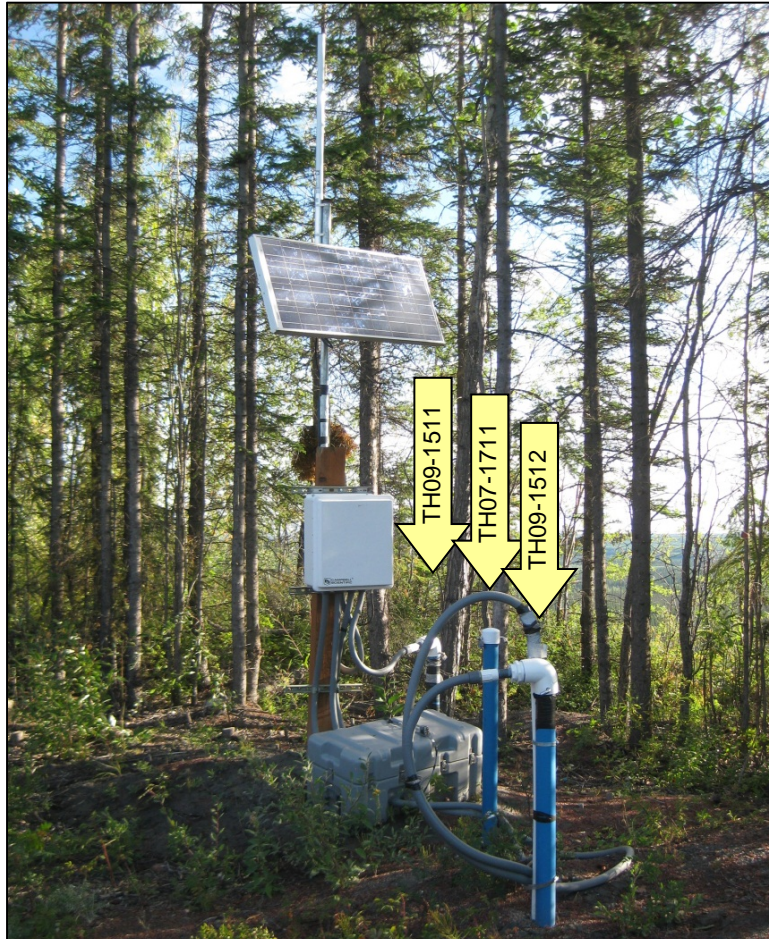
Figure 4. Relative locations of the measured casings at Rich113. Vertical arrows are labeled with the test hole identifiers. The edge of the bluff overlooking the Copper River is immediately beyond the spruce trees behind the installations, and the Richardson Highway is behind the photographer. (Photograph by M. Darrow)

For spatial reference of the measured locations, Figure 4 is a photograph of the casing locations relative to each other and the bluff edge. Figure 5a and b are plots of cumulative displacement obtained from the three instruments. The readings collected with the traditional inclinometer probe (shown as green diamonds and labeled with the prefix “SI” in each figure) indicate movement occurring at approximately 55 ft bgs, with between 0.5 and 0.6 in. of cumulative displacement within the analyzed time frame. Although small, this movement is consistent in depth and character with that previously recorded for this site.

We installed the INC500 inside a guide casing within the boring TH09-1511 (see Figure 4). When we extracted the M-IPI device, we measured the casing with the inclinometer probe for comparison. Thus, the cumulative displacements from the INC500 and the inclinometer probe shown in Figure 5a are directly comparable. Visual analysis indicates that the two sets of readings are very similar, with a maximum difference in readings of 6.89×10^{-2} in. Readings from equivalent depths for these two instruments are plotted in Figure 5c. The solid red line at 45° indicates a 1:1 relationship. For each pair of readings, the precision (or repeatability) of the inclinometer probe and INC500 is shown as horizontal or vertical whiskers, respectively. Examination of the measurement pairs indicates that each point lies within the precision of the inclinometer probe device; thus, the readings cannot be differentiated from each other.

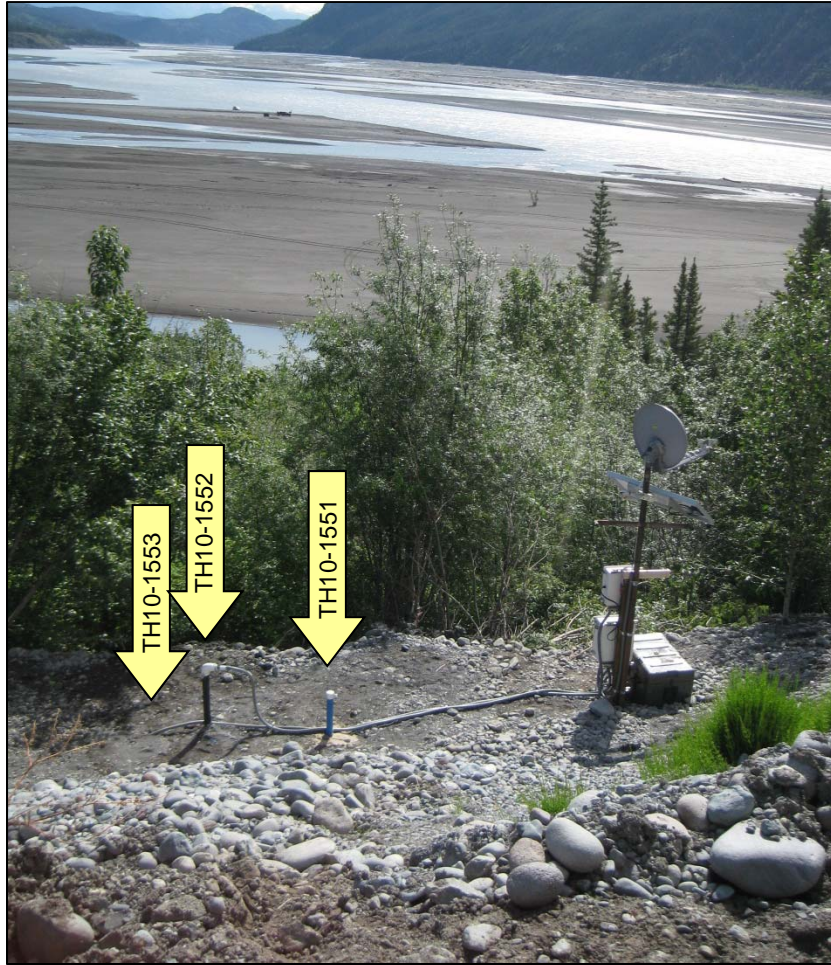
Figure 8. Relative locations of the measured casings and piezometer installation at the Chitina Dump Slide. Vertical arrows are labeled with the test hole identifiers; the installations were located on a drill bench downhill of the roadway embankment. This photograph was taken from the McCarthy Road embankment looking east towards the Copper River. (Photograph by M. Darrow)

For spatial reference of the measured locations, Figure 8 is a photograph of the casing locations relative to each other. As a first step in analysis, inclinometer probe measurements were used to evaluate the effectiveness of tamping the sand backfill around the casing within the boring. Voids created by bridging within the loosely poured sand into the annular space in a boring often are evident in sagging of the casing within a few weeks after the initial installation. The data collected during the summer of 2010 was evaluated by assigning two different initial dates, June 17 (date of installation) and June 25 (one week later). Below the shear zone, these sets of readings differed by 0.03 in. at the most; thus, we considered any sagging of the casing as minor, and used June 17 as the initial reading for the rest of the analysis. Figure 9b contains all of the cumulative displacement measurements from 2010, which indicate a shear zone between 14.3 and 18.3 ft bgs and about 1.7 in. of movement over the three month measurement period.

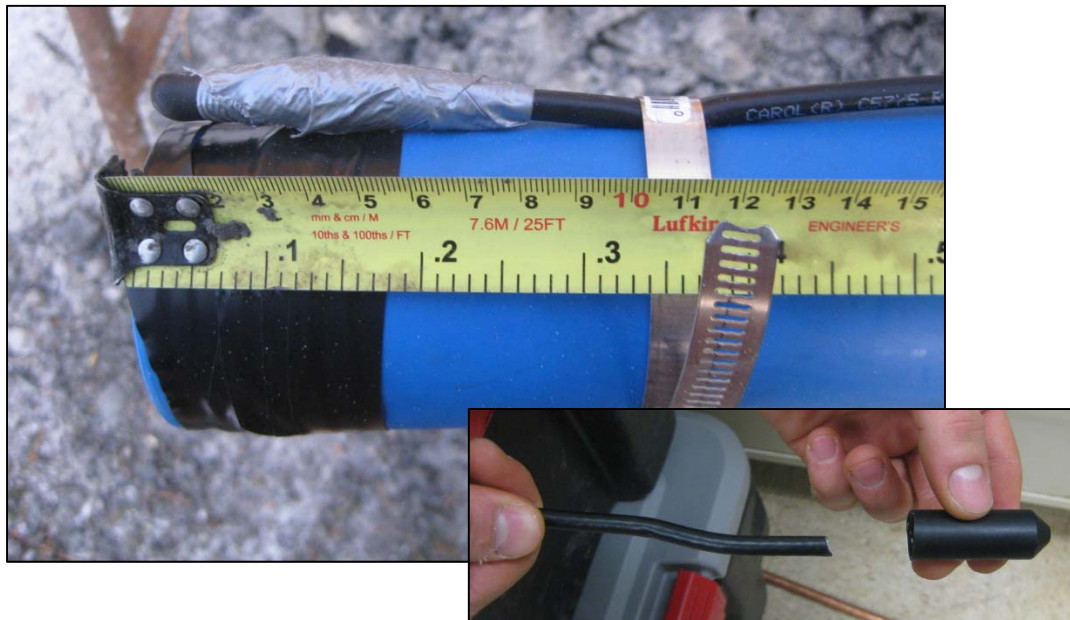
Figure A-2. Configuration of coaxial (TDR) cable at the bottom of the guide casing prior to installation. Inset illustrates sealing the cable end with an adhesive cap. (Photographs by M. Darrow, Nov. 2009)

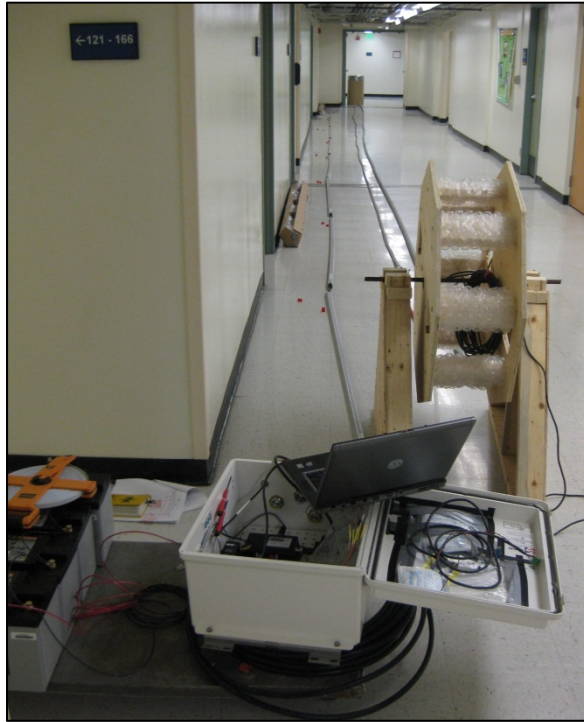
Figure A-3. Conducting a “hallway” test with the INC500 and SAA devices wired into the ADAS enclosure. (Photograph by M. Darrow, March 2010)

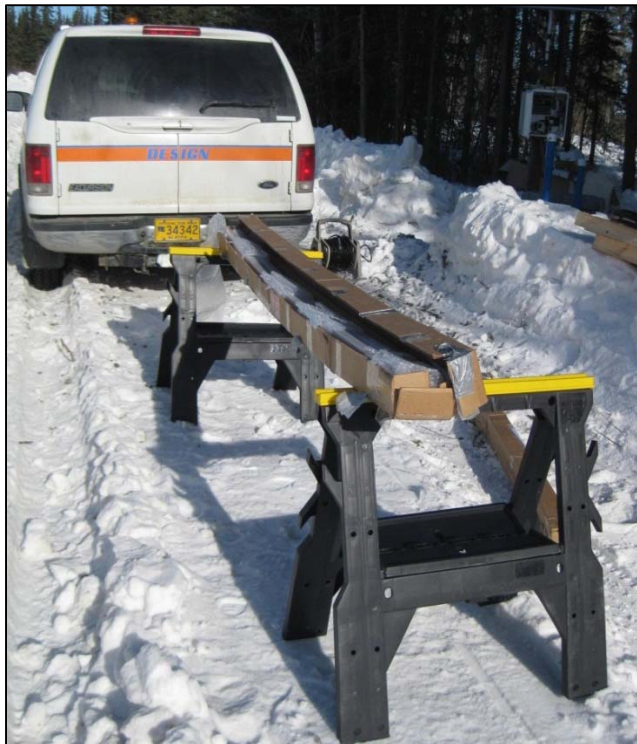
Figure A-4. Staging the INC500 device on sawhorses in March 2010. (Photograph by M. Darrow)

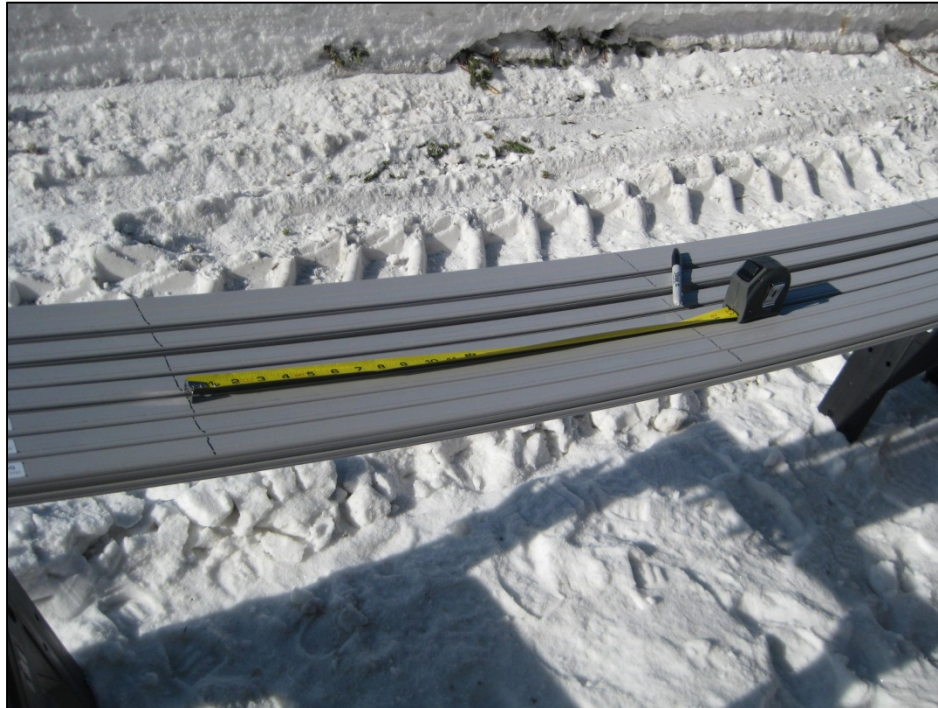
Figure A-5. Marking the INC500 for placement of centralizers. (Photograph by M. Darrow, March 2010)

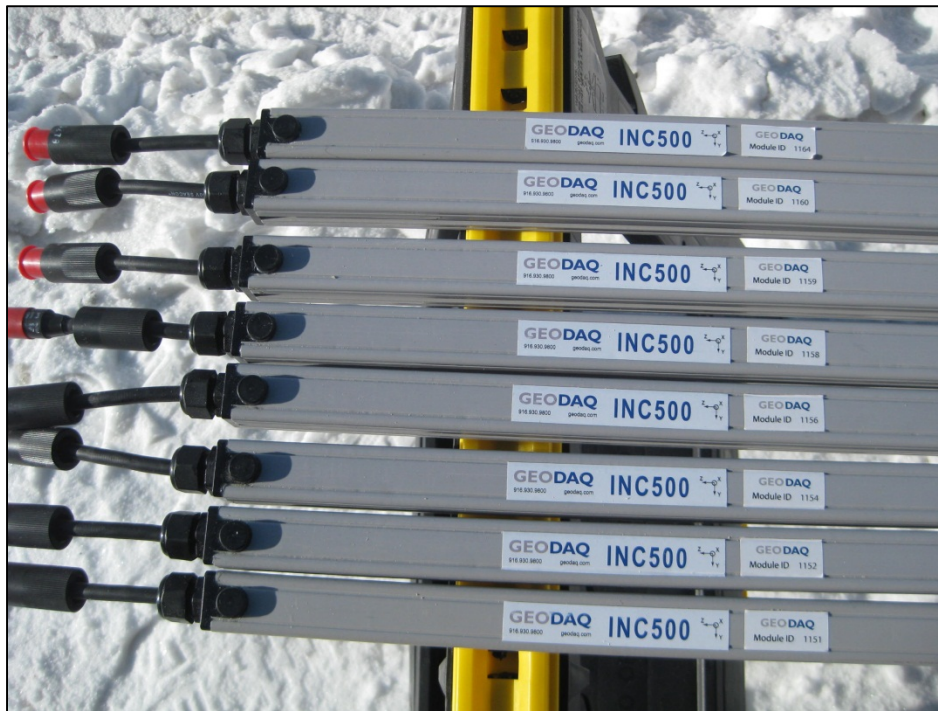
Figure A-6. Order of INC500 module serial numbers before installation. It is good practice to record this order both in a field book and through photographs. (Photograph by M. Darrow, March 2010)

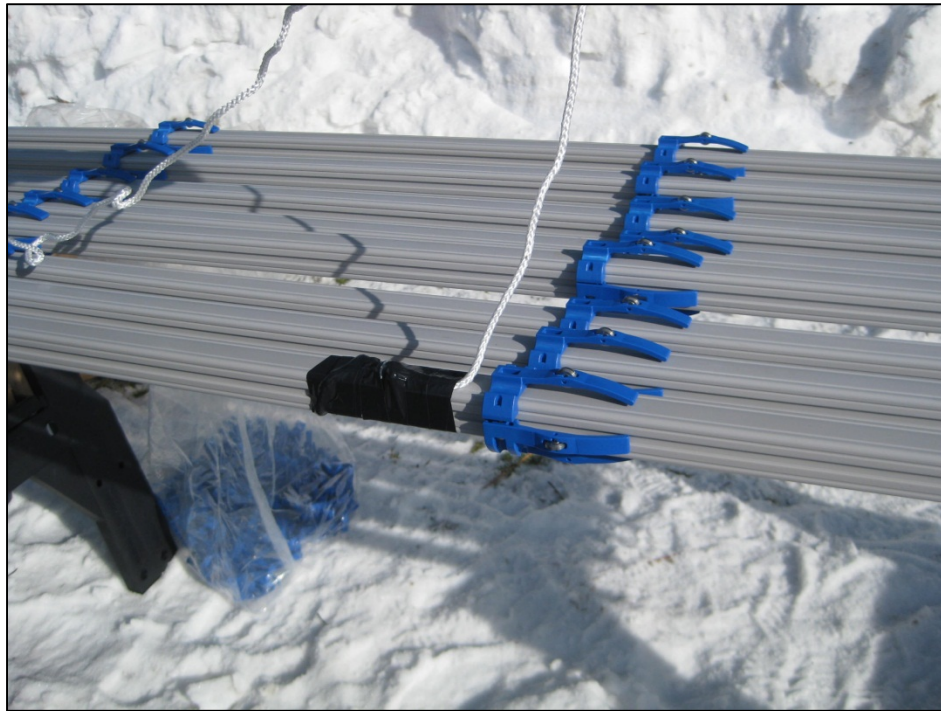
Figure A-8. Attaching the safety line to the lowest module. (Photograph by M. Darrow, March 2010)

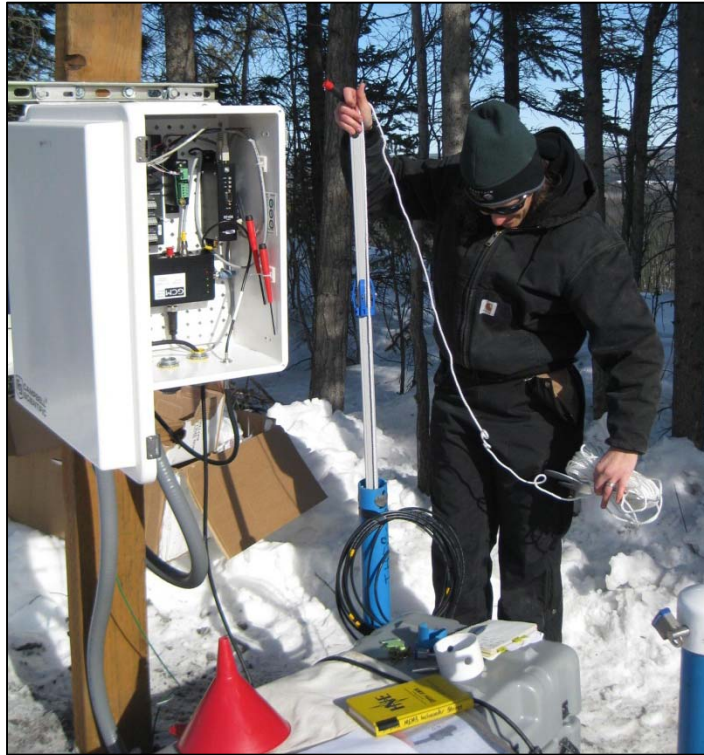
Figure A-9. Lowering the first INC500 module down the guide casing. (Photograph courtesy of A. Parsons, March 2010)

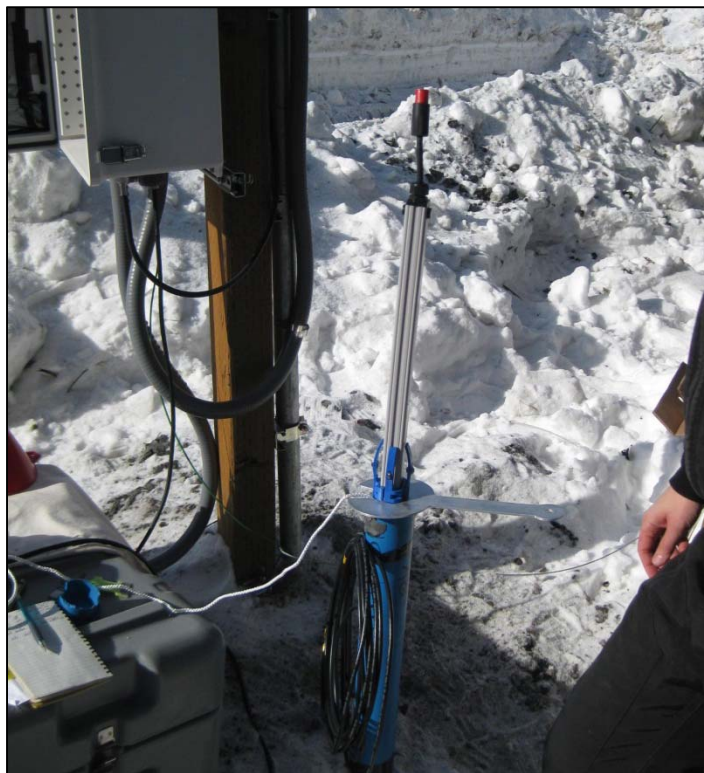
Figure A-10. First INC500 module resting on fork. (Photograph courtesy of A. Parsons, March 2010)

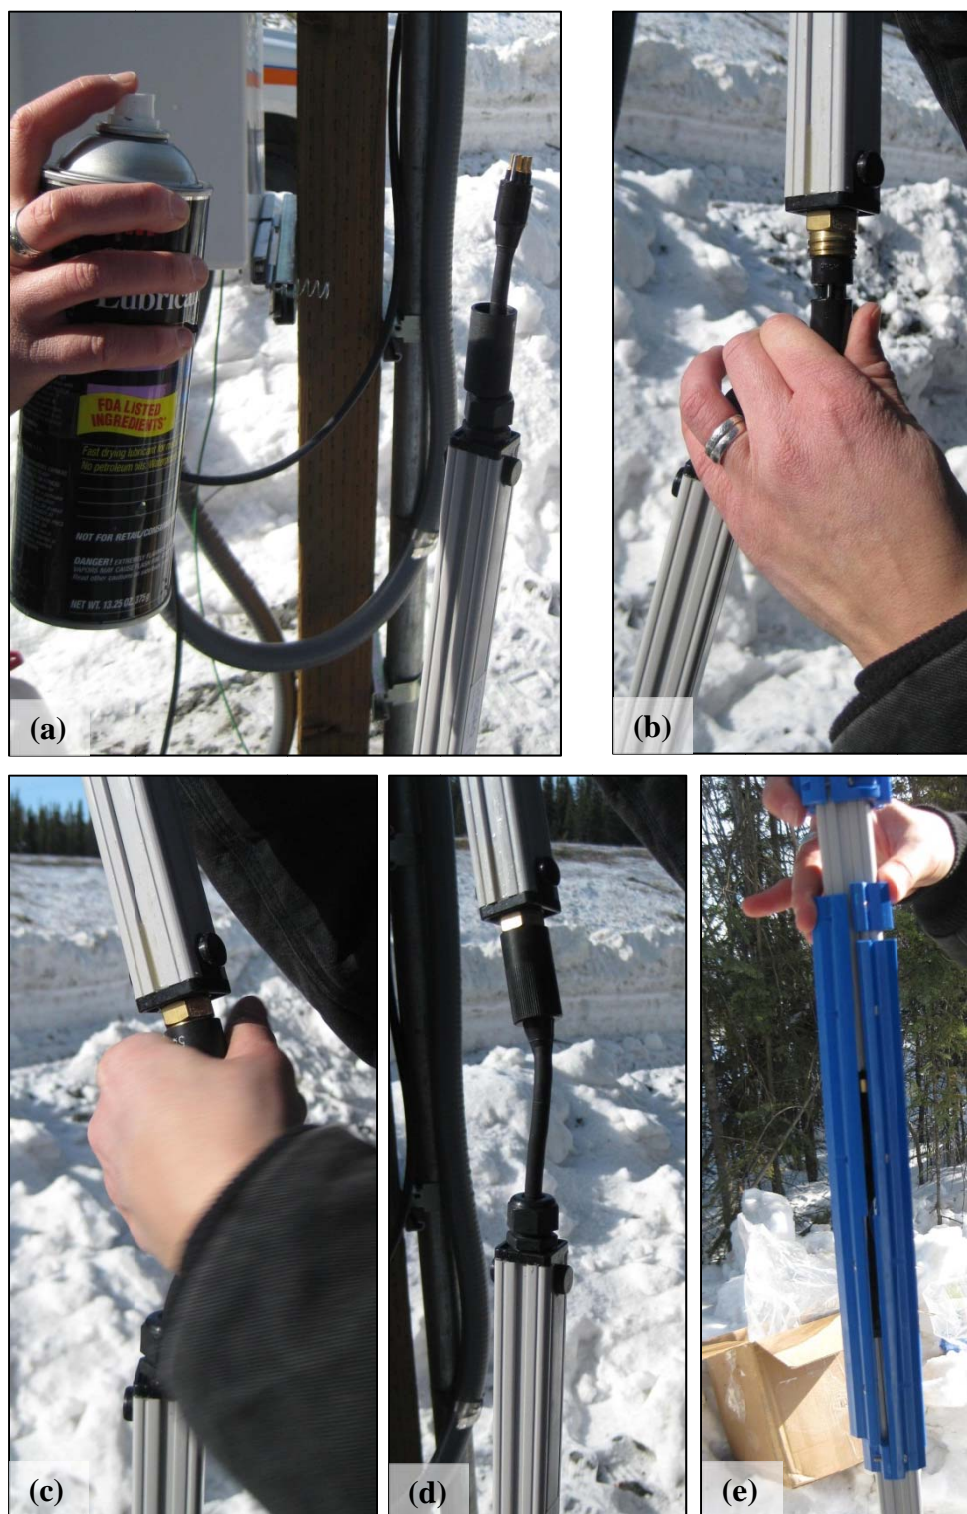
Figure A-11. Steps in the assembly of the INC500 modules. (a) Spraying the connections with silicon; (b) plugging the water-tight connectors together; (c) screwing the threaded connections together for the water-tight connection; (d) connected modules; e) attaching the coupler assembly. (Photographs courtesy of A. Parsons, March 2010)

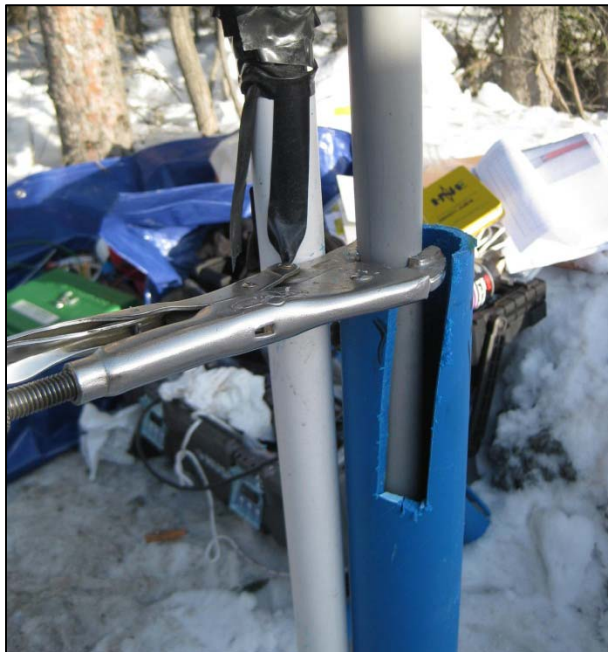
Figure A-13. Installing inner 1.05-in. PVC into guide casing for SAA device. Slot cut into the guide casing was to allow tightening of the hose clamp at the top of the PVC casing (see Figure A-14). White 1-in. PVC to the left was for a thermistor string. (Photograph by M. Darrow, March 2010)

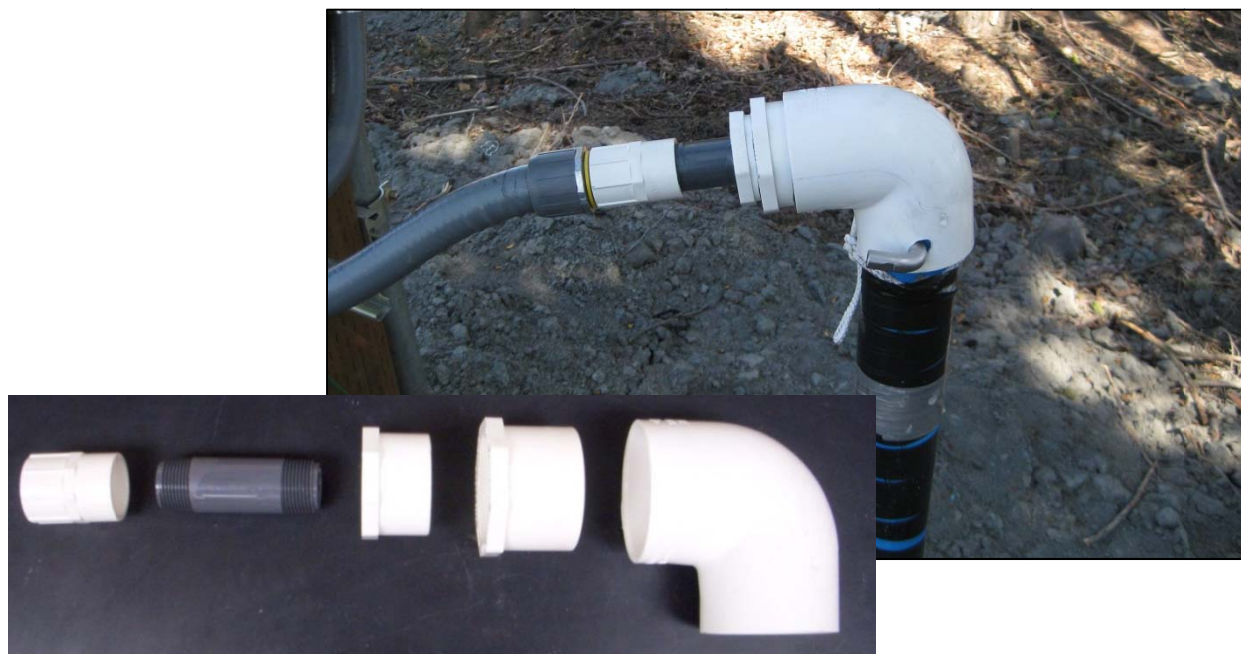
Figure A-18. Guide casing to flexible conduit adapter in place on TH09-1511 casing. Inset illustrates the various PVC fittings that comprise the adapter. (Photographs by M. Darrow, May 2010)

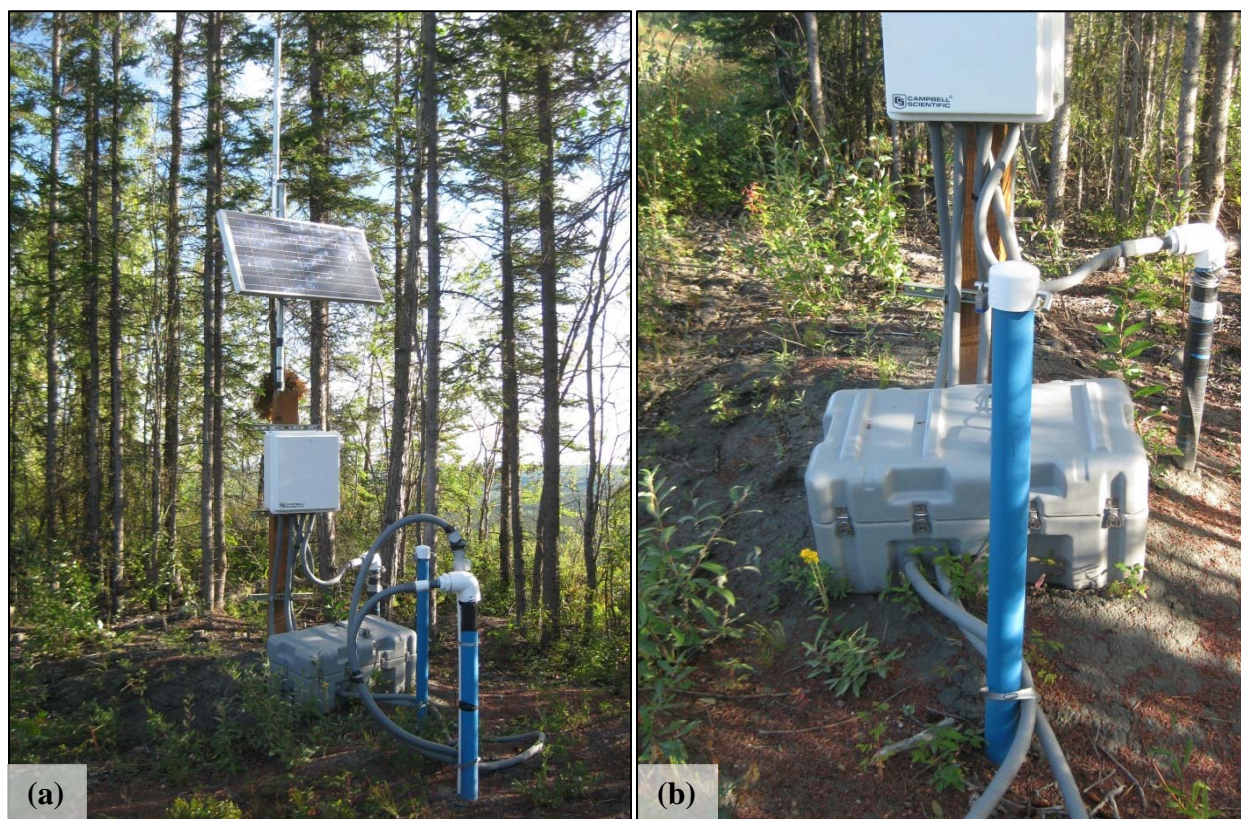
Figure A-19. Final configuration of the Rich113 site. (a) Complete ADAS overview; (b) TH07-1711 in foreground with battery box and ADAS; TH09-1511 is to the right. (Photographs by M. Darrow, Aug. 2011)

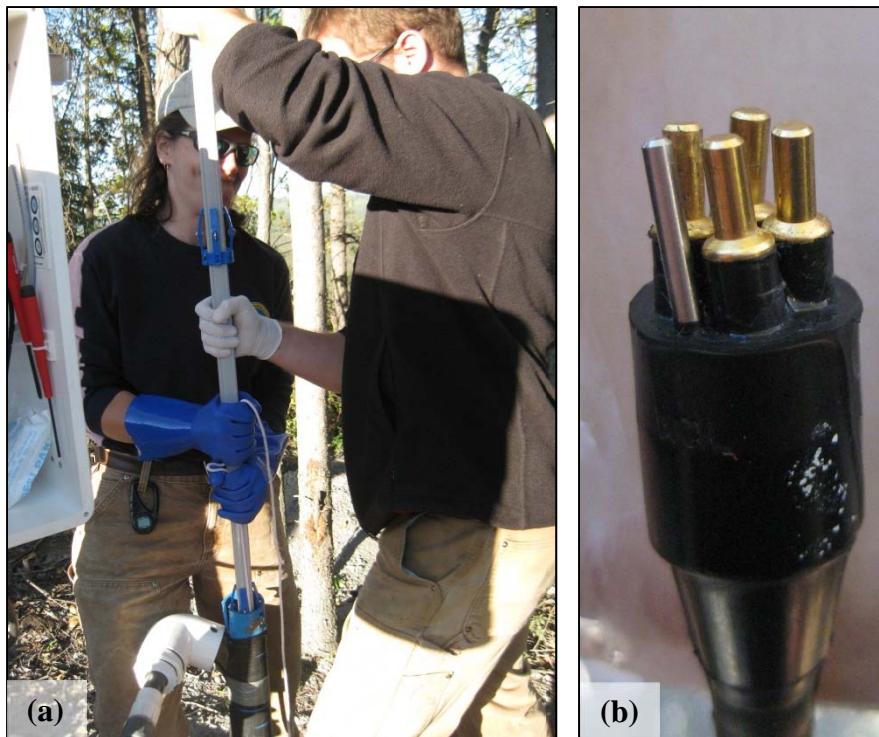
Figure A-21. Retrieving the INC500 in September 2010 to adjust the positioning of the centralizers. (a) Pulling the INC500 from the guide casing. (b) Some of the connectors demonstrated twisting. (Photographs courtesy of S. Huang)

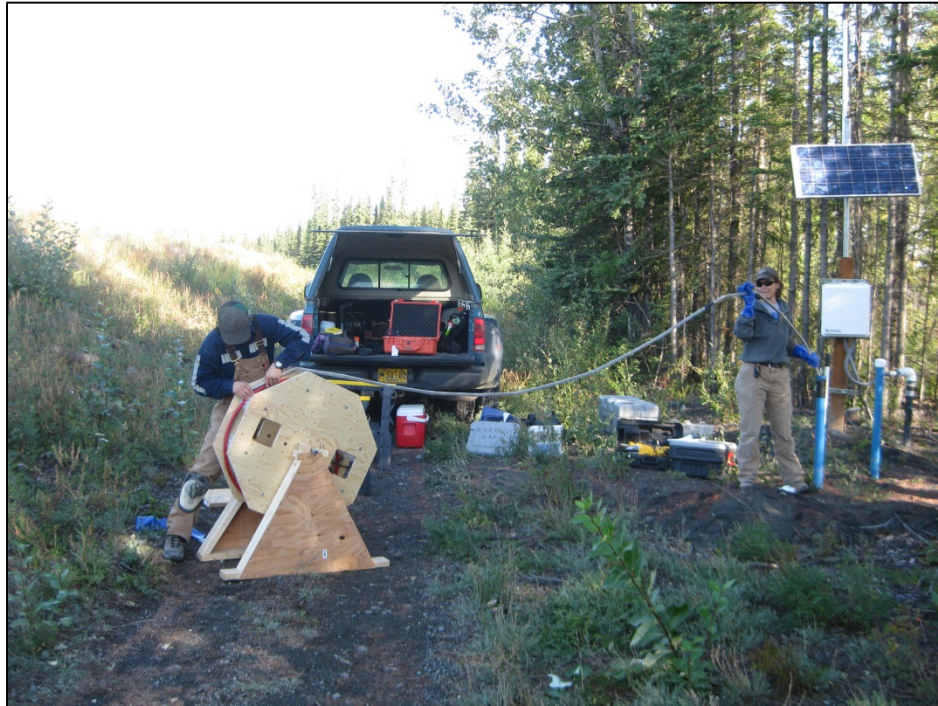
Figure A-22. Retrieving the SAA in August 2011, and replacing the device on the shipping reel. (Photograph courtesy of J. Yao)

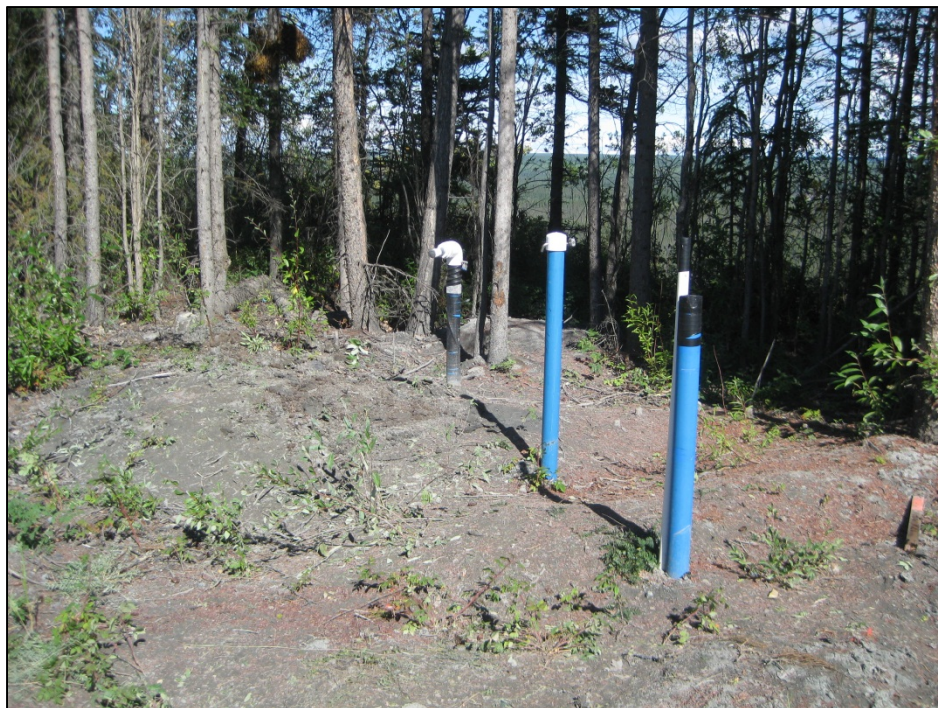
Figure A-23. Final configuration of the Rich113 site in August 2011. The post that supported the ADAS was cut off at the ground surface. Only the guide casings remain for manual inclinometer probe readings. (Photograph by M. Darrow)

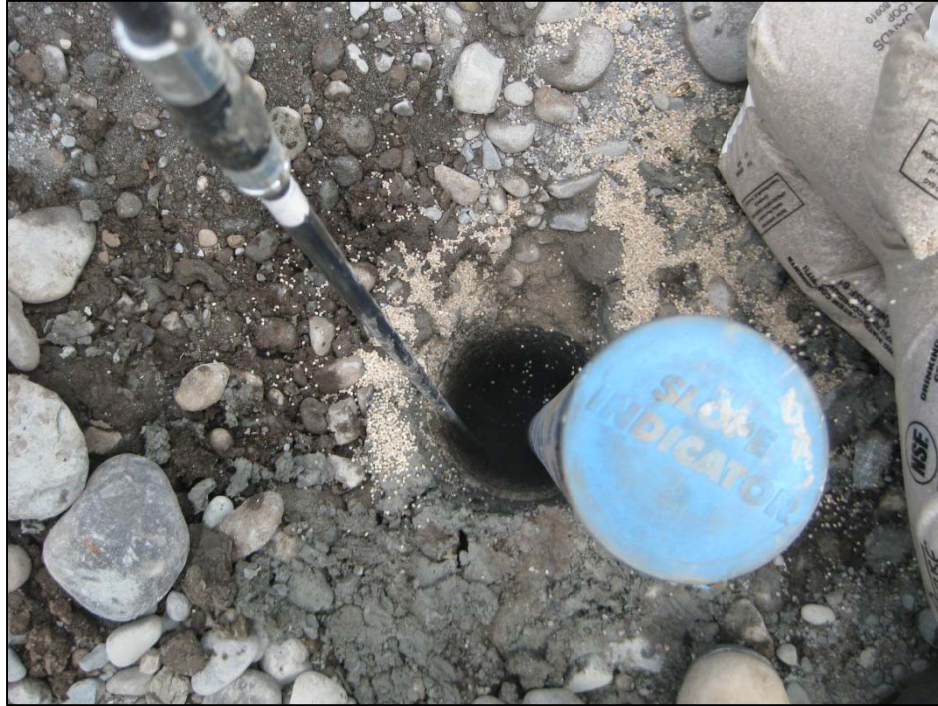
Figure B-1. Tamping dry sand backfill around the guide casing. (Photograph by M. Darrow, June 2010)

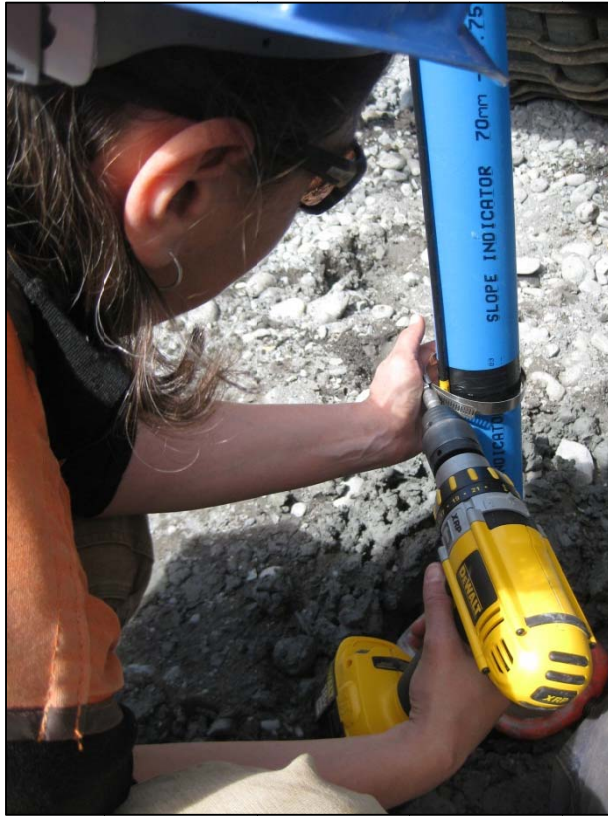
Figure B-3. Attaching the coaxial (TDR) cable with hose clamps at 10-ft intervals. (Photograph courtesy of T. Haller, June 2010)

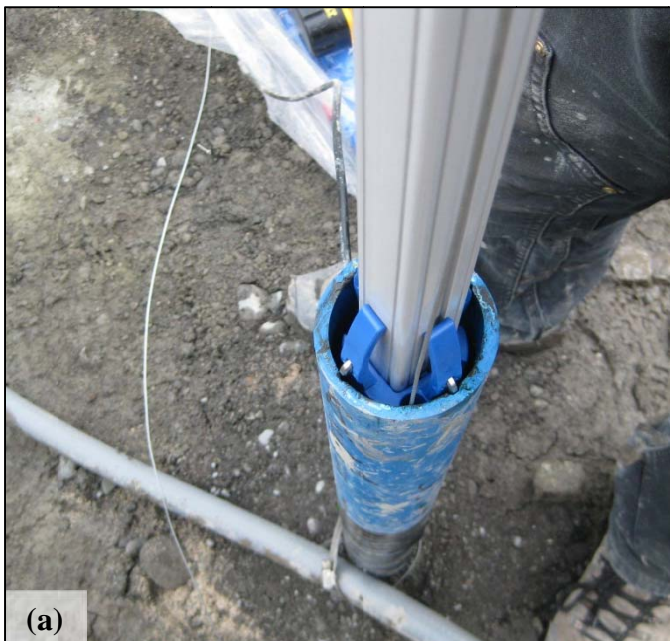
Figure B-4. Installing the INC500 within the guide casing. (a) This photograph shows the arrangement of the centralizers and the wire rope used as a safety line; (b) some of the insets for the machine screw popped out of the plastic housing. (Photographs by M. Darrow, June 2010)

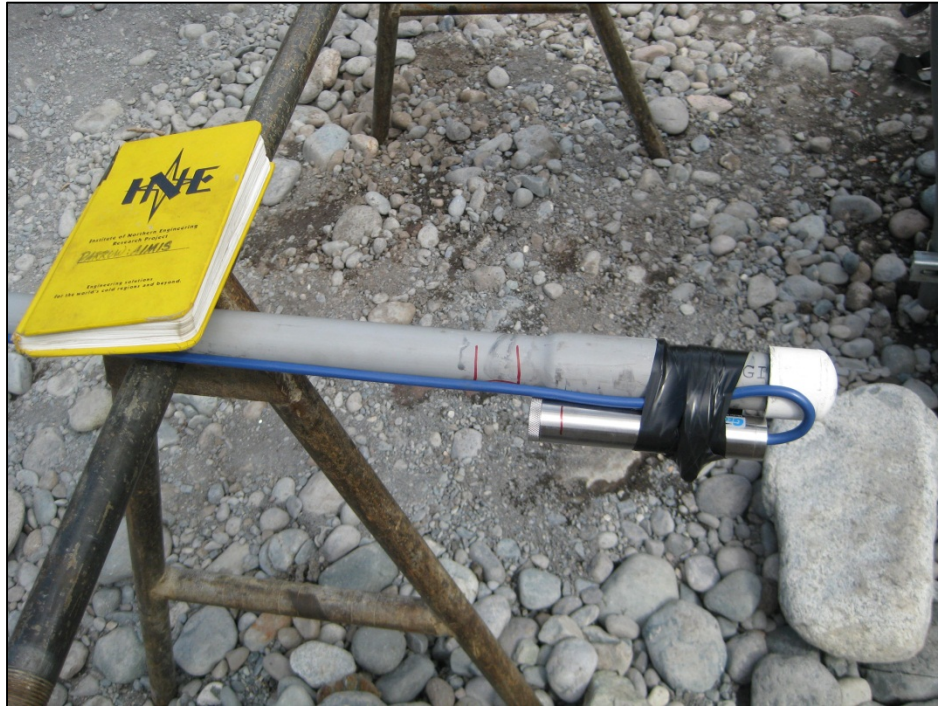
Figure B-5. Placement of vibrating wire piezometer on PVC casing for installation into TH10-1553. (Photograph by M. Darrow, June 2010)

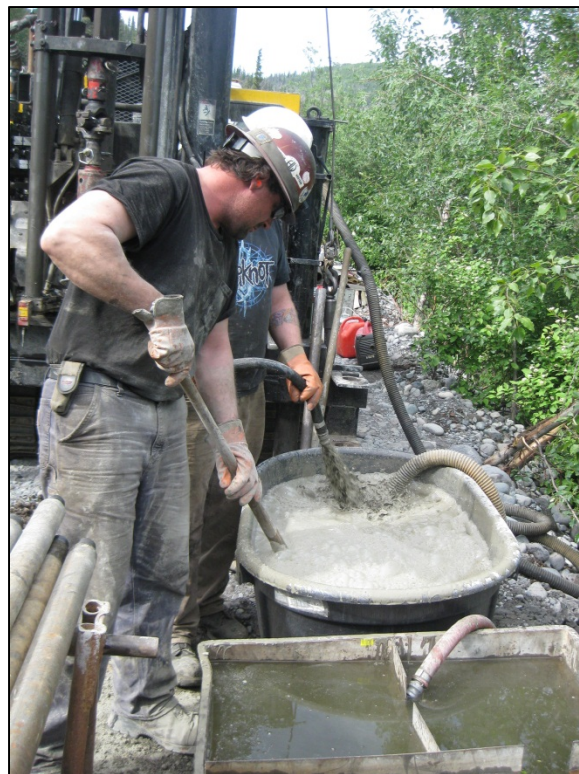
Figure B-6. Preparing the cement-bentonite grout for backfill into TH10-1553. (Photograph by M. Darrow, June 2010)

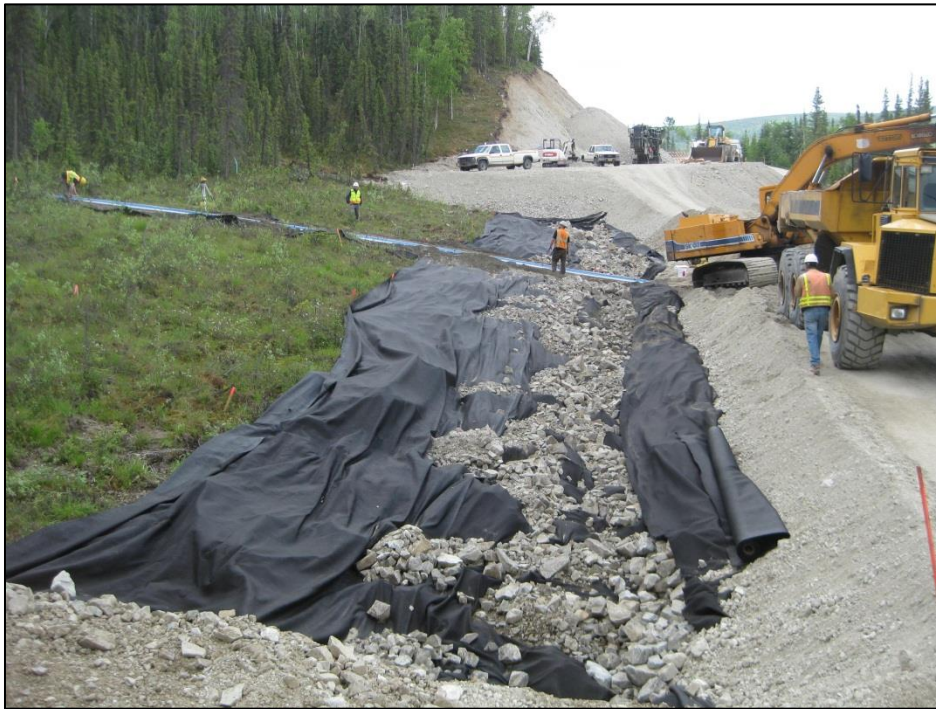
Figure C-1. Looking southeast towards the instrumented cross section. Geotextile with some ACE material is present in the foreground. (Photograph by M. Darrow, June 2012)

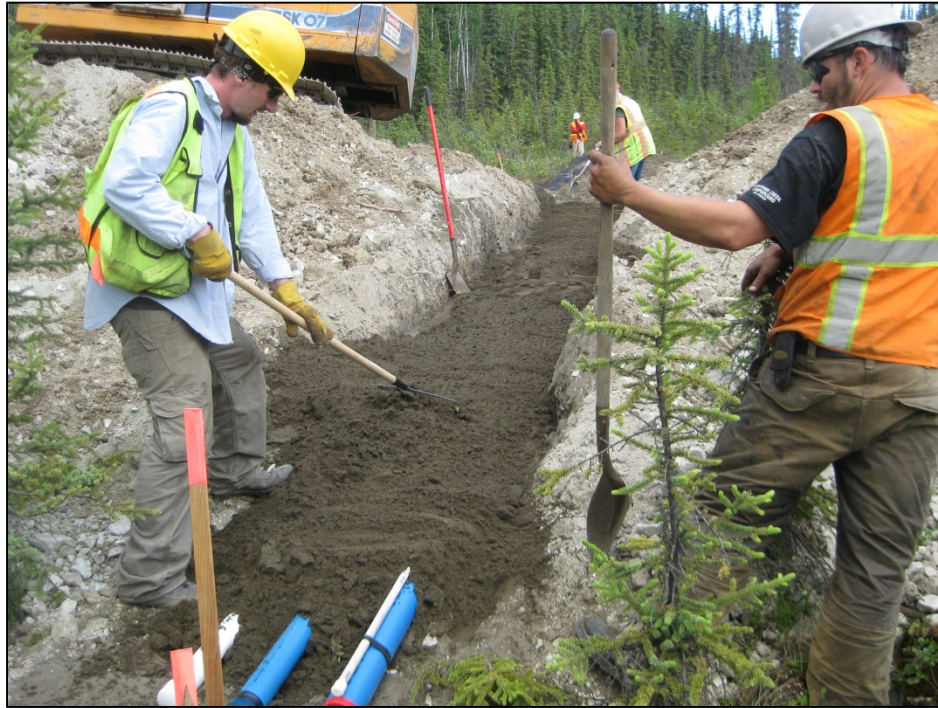
Figure C-3. Covering the casings with sand bedding. (Photograph by M. Darrow, June 2012)

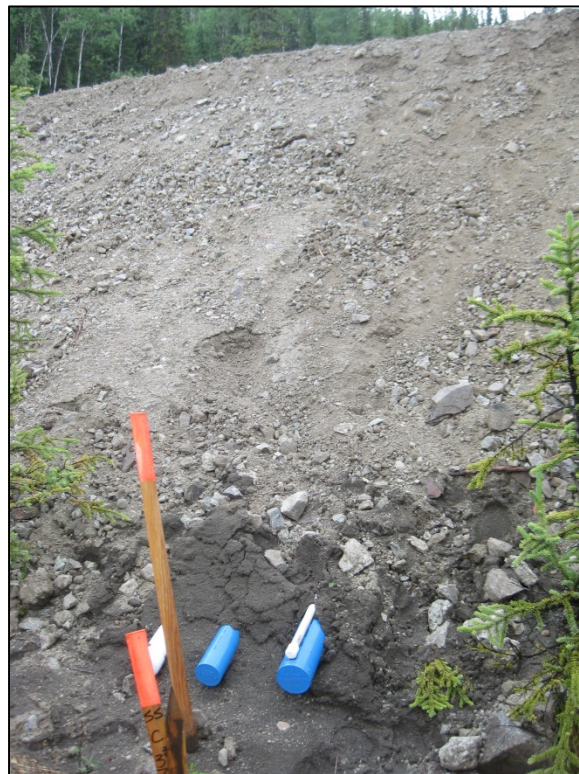
Figure C-4. Downhill toe of embankment with thermal berm and exposed casing ends. (Photograph by M. Darrow, July 2012)

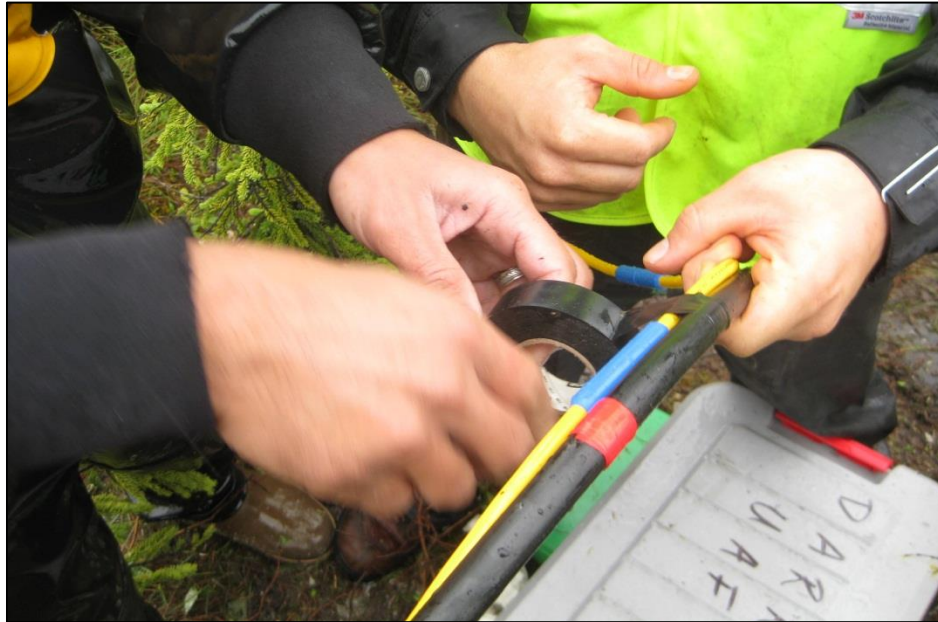
Figure C-5. Wrapping BeadedStream temperature acquisition cable (TAC) to thermistor cable for installation. (Photograph by M. Darrow, July 2012)

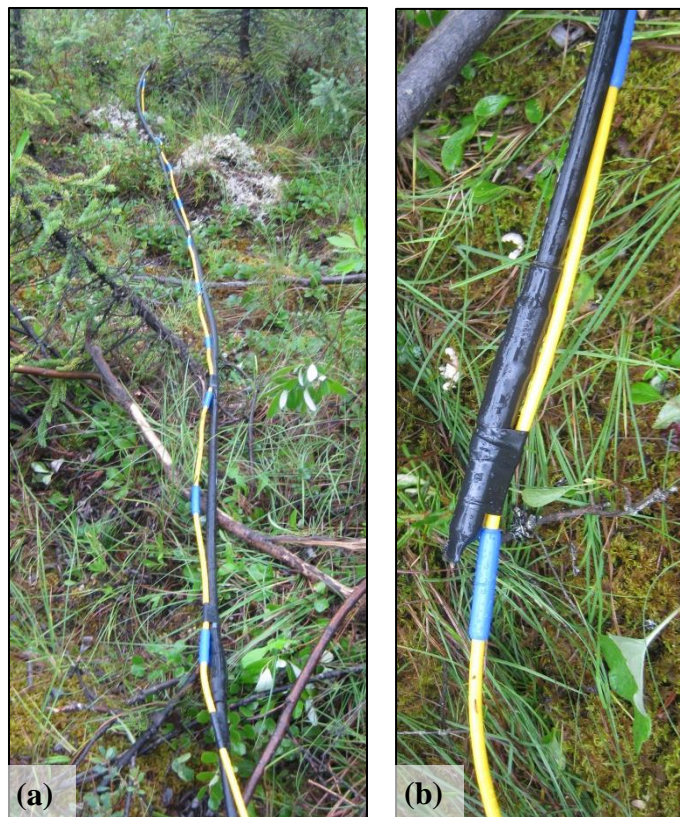
Figure C-6. Alignment of TAC and thermistor cable. (a) Location of thermistor beads relative to TAC sensors was recorded, (b) as well as the location of the final thermistor bead. (Photographs by M. Darrow, July 2012)

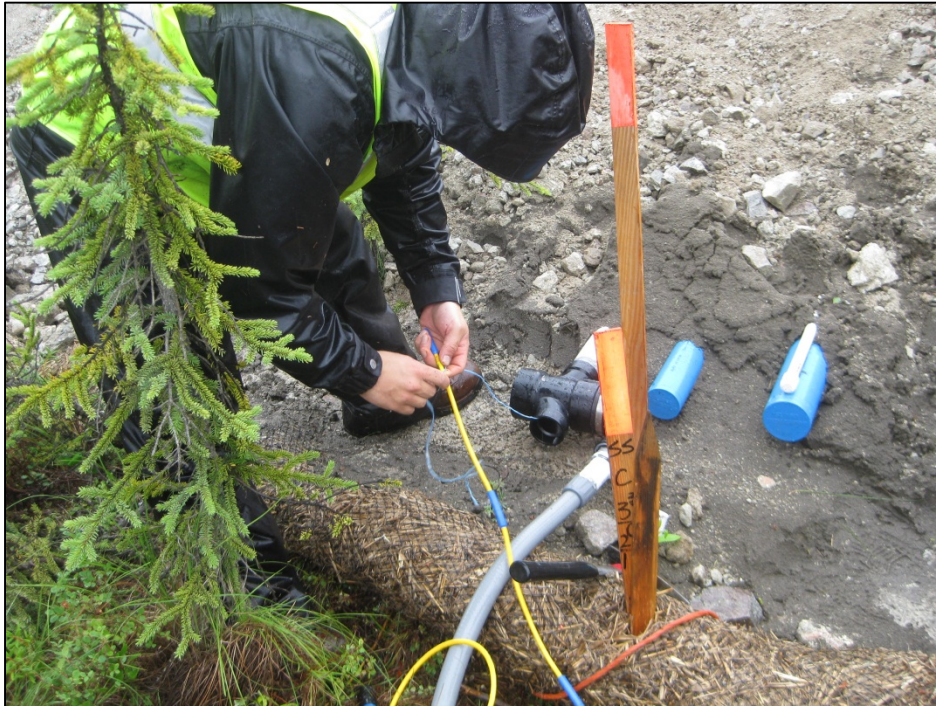
Figure C-7. Attaching the pull rope to the end of the TAC device. (Photograph by M. Darrow, July 2012)

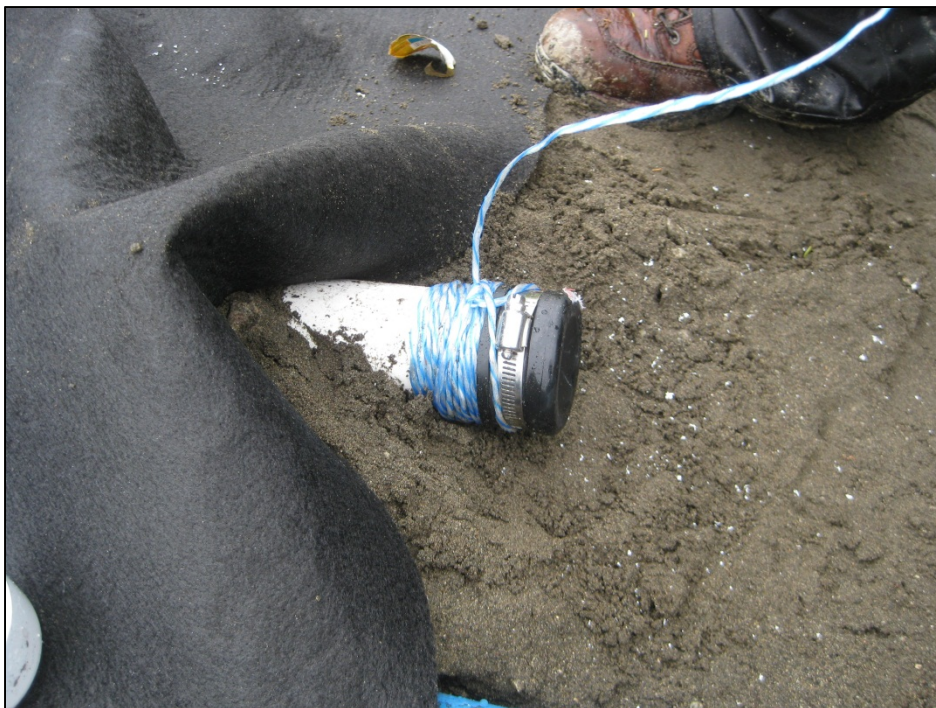
Figure C-8. Uphill termination of the casing containing the TAC and thermistor string. (Photograph by M. Darrow, July 2012)
